Section 5

Troubleshooting

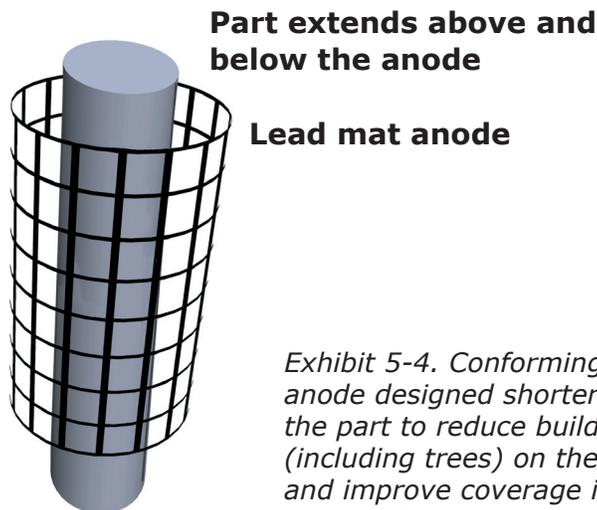
Exhibit 5-4. Conforming anode designed shorter than the part to reduce buildup (including trees) on the ends and improve coverage in the center of the part.

Also, reducing the size of the anode area can sometimes make a big difference in coverage depending on the shape of the workpiece. For example, if you are plating a flat surface and you select an anode that is much larger in size, chromium deposits will quickly buildup on the edges, but the center of the part may have zero coverage. To correct this problem, use an anode that is smaller than the surface being plated. The same is true of inside diameters and outside diameters. Use an anode that is slightly shorter than the part to reduce a buildup at the ends and improve coverage.

With cylindrical parts, such as shafts, the resulting chrome deposit has a "dog bone" contour; thicker chrome on the ends and thinner chrome in the center. This effect can be reduced by using a conforming anode that is shorter than the part, or by masking off the top and bottom of the anode. Other surface shapes are more difficult to deal with, like those shown in Exhibit 5-5. Recessed areas

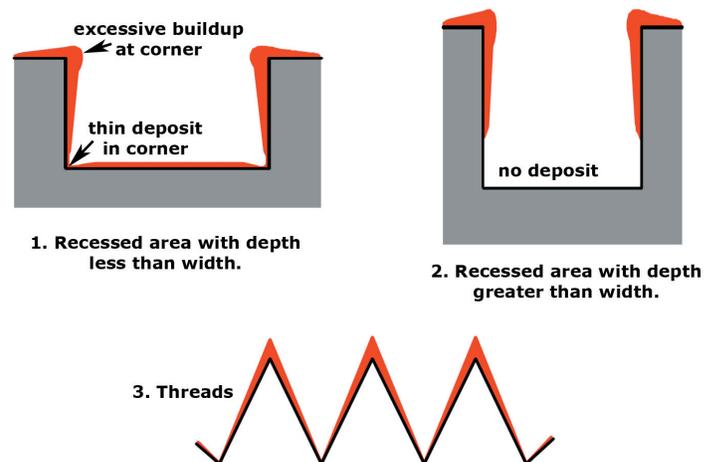
Exhibit 5-5. Examples of expected chromium deposits for various shapes.

that are wider than they are deep (see #1) can be chrome plated, however, the deposit will be non-uniform. Recessed areas that are deeper than they are wide (see #2) are very difficult to plate. Threads also present problems (see #3); in many cases, the non-uniform deposition of chrome alters the thread diameter and angle.

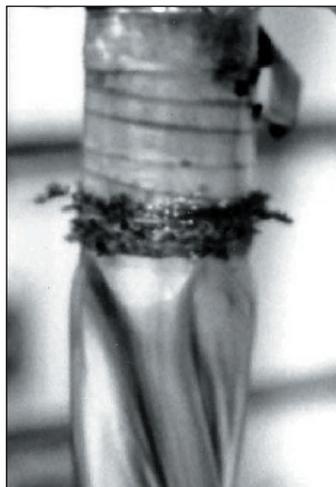
Exhibit 5-6. Trees

- Excessive, outward growth of metallic chromium, resembling branches from the trunk of a tree
- Can short-circuit rectifier, if they grow long enough to contact anode
- Causes:
 - High localized current density (at ends or edges of part)
 - Improper alignment of anode with part
 - High chrome-to-catalyst ratio

Chrome Trees growing from lead tape masking at top of fluted rotor.

density several times higher. This results in the formation of chrome that resembles branches on a tree. Examples of chrome trees are shown in Exhibits 5-6 and 5-7. Chrome trees can be extremely harmful. During long plating cycles, they can "grow" all the way to the anode, causing a short that may damage the part and/or the rectifier.

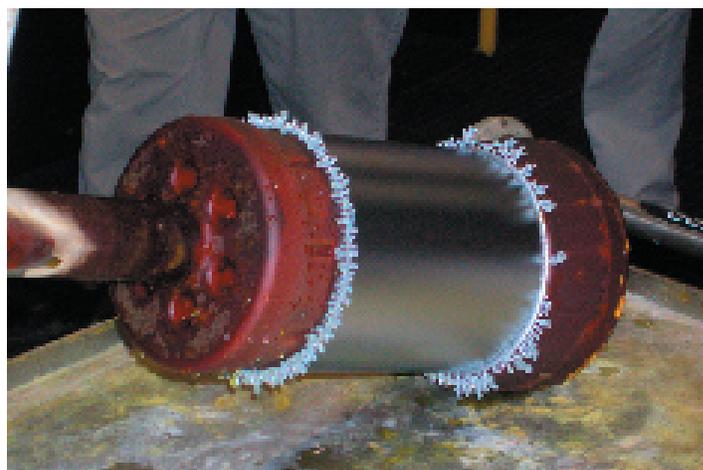
Exhibit 5-7. Trees formed at edges of an OD that is masked with wax.

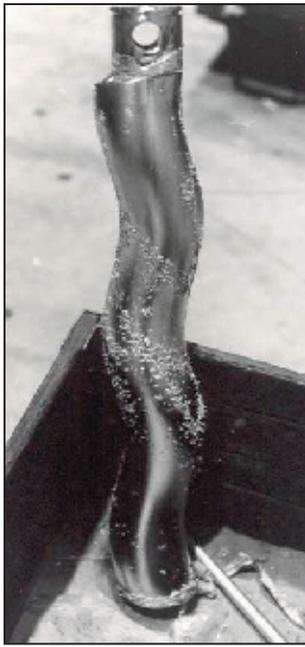
Exhibit 5-8. Peeled Chrome: A heavy buildup of chrome has blistered, indicating an adhesion problem.

Poor adhesion refers to peeling, blistering or lifting of the chromium deposit from the work piece. It can be caused by several factors, most of which are related to pre-plate procedures. Examples of poor adhesion are shown in Exhibits 5-8 and 5-9.

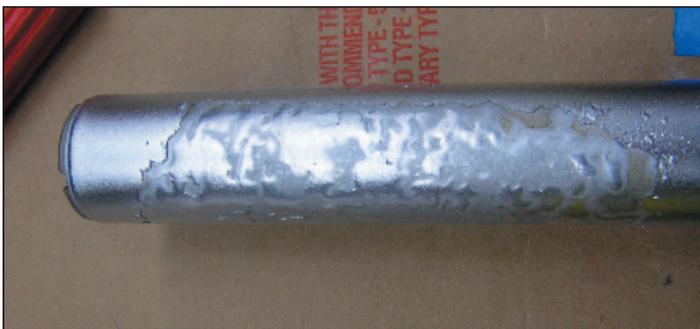
Exhibit 5-9. Picture of peeling and blistering.

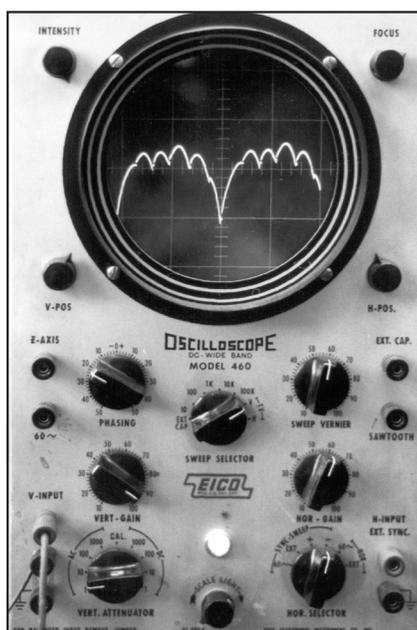
Exhibit 5-10. Rectifier Damage: This oscilloscope trace indicates that the SCR power supply has damaged components that can cause peeled chrome. All of the humps should be the same amplitude (height).

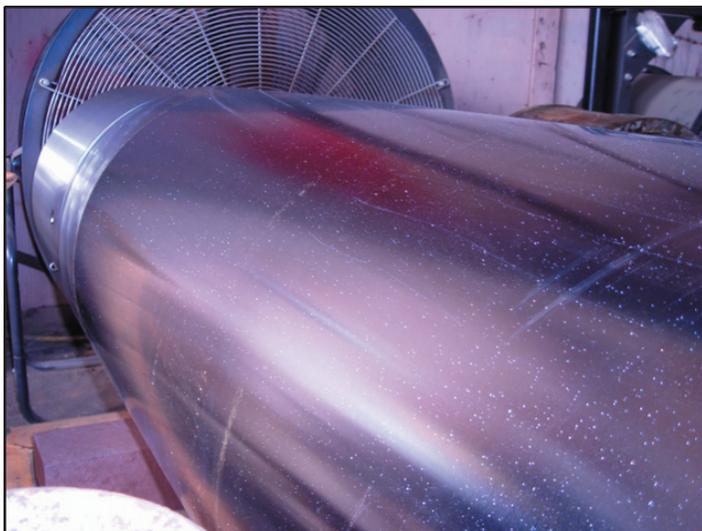
Exhibit 5-11. Long shaft with thousands of pits after plating. These pits were caused by inadequate pre-plate grinding.

Pitting is a common defect in hard chromium deposits, and a difficult problem to troubleshoot because there are so many possible causes. A photograph of a long shaft with thousands of pits after plating is shown in Exhibit 5-11. These pits were caused by inadequate pre-plate grinding.

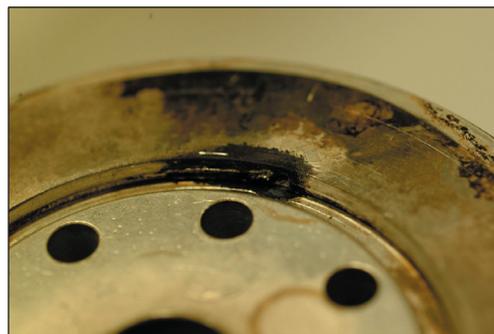
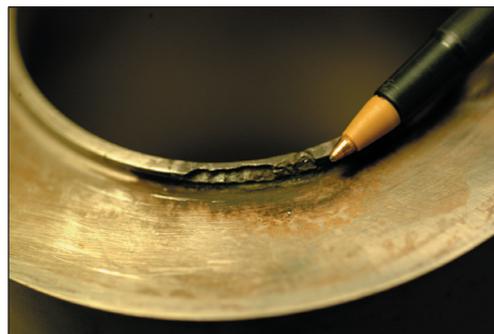
Exhibit 5-12. Arc damage to chrome plated parts.

Arc damage can occur to parts during plating if they are not firmly held by fixtures or contact plates. Arcing can lead to severe damage, and

often results in a scrapped part. A photograph of arc damage is shown in Exhibit 5-12.

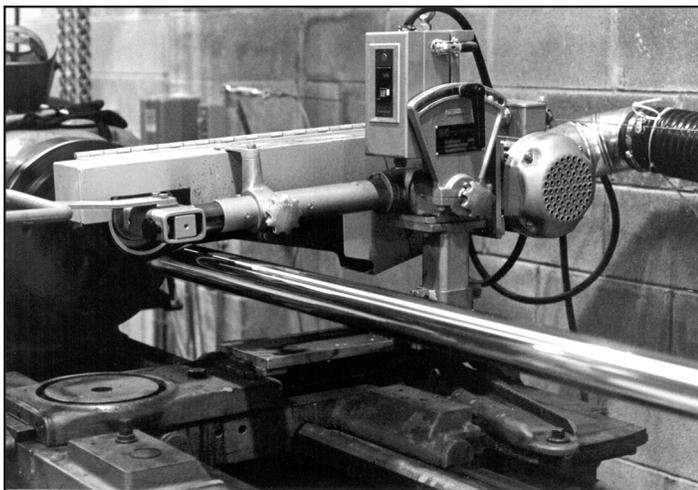
Exhibit 5-13. Preplate Polishing: Smoother profiles can improve the corrosion resistance of the plated part.

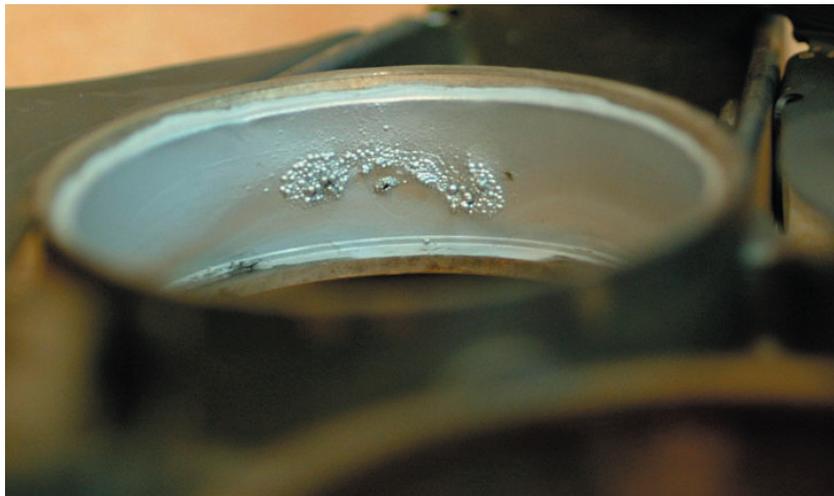
4. Look at the part below. What problems do you notice?

What potential actions may improve the plating of this part? (check all that apply)?

- a. Pumice scrub the part before plating
- b. Increase the chromium-to-catalyst ratio

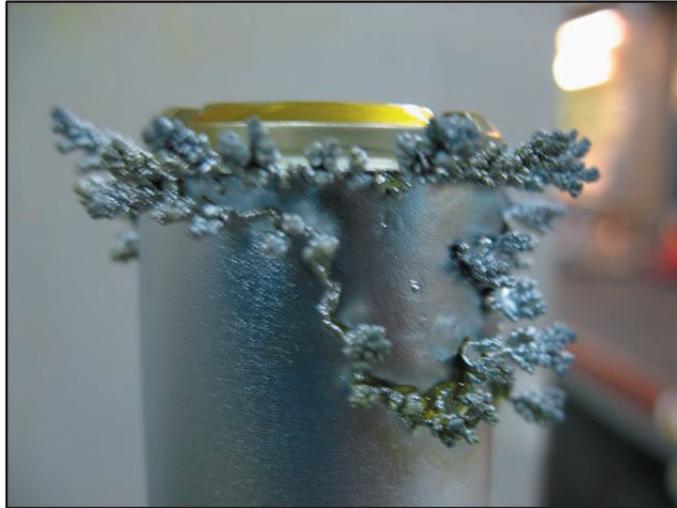
11. Look at the small pin shown below. What is the most likely cause of this problem?

- a. Low chromium to sulfate ratio.
- b. Excessively high bath temperature.
- c. Interruption of current during plating cycle.
- d. Poor masking job.
